Remedial Action Work Plan **PCB-Contaminated Topsoil**

Institute of Technology at Syracuse Central

NYSDEC Spill No. 13-03516

ATL Engineering Report No. AE094CE-03-07-13

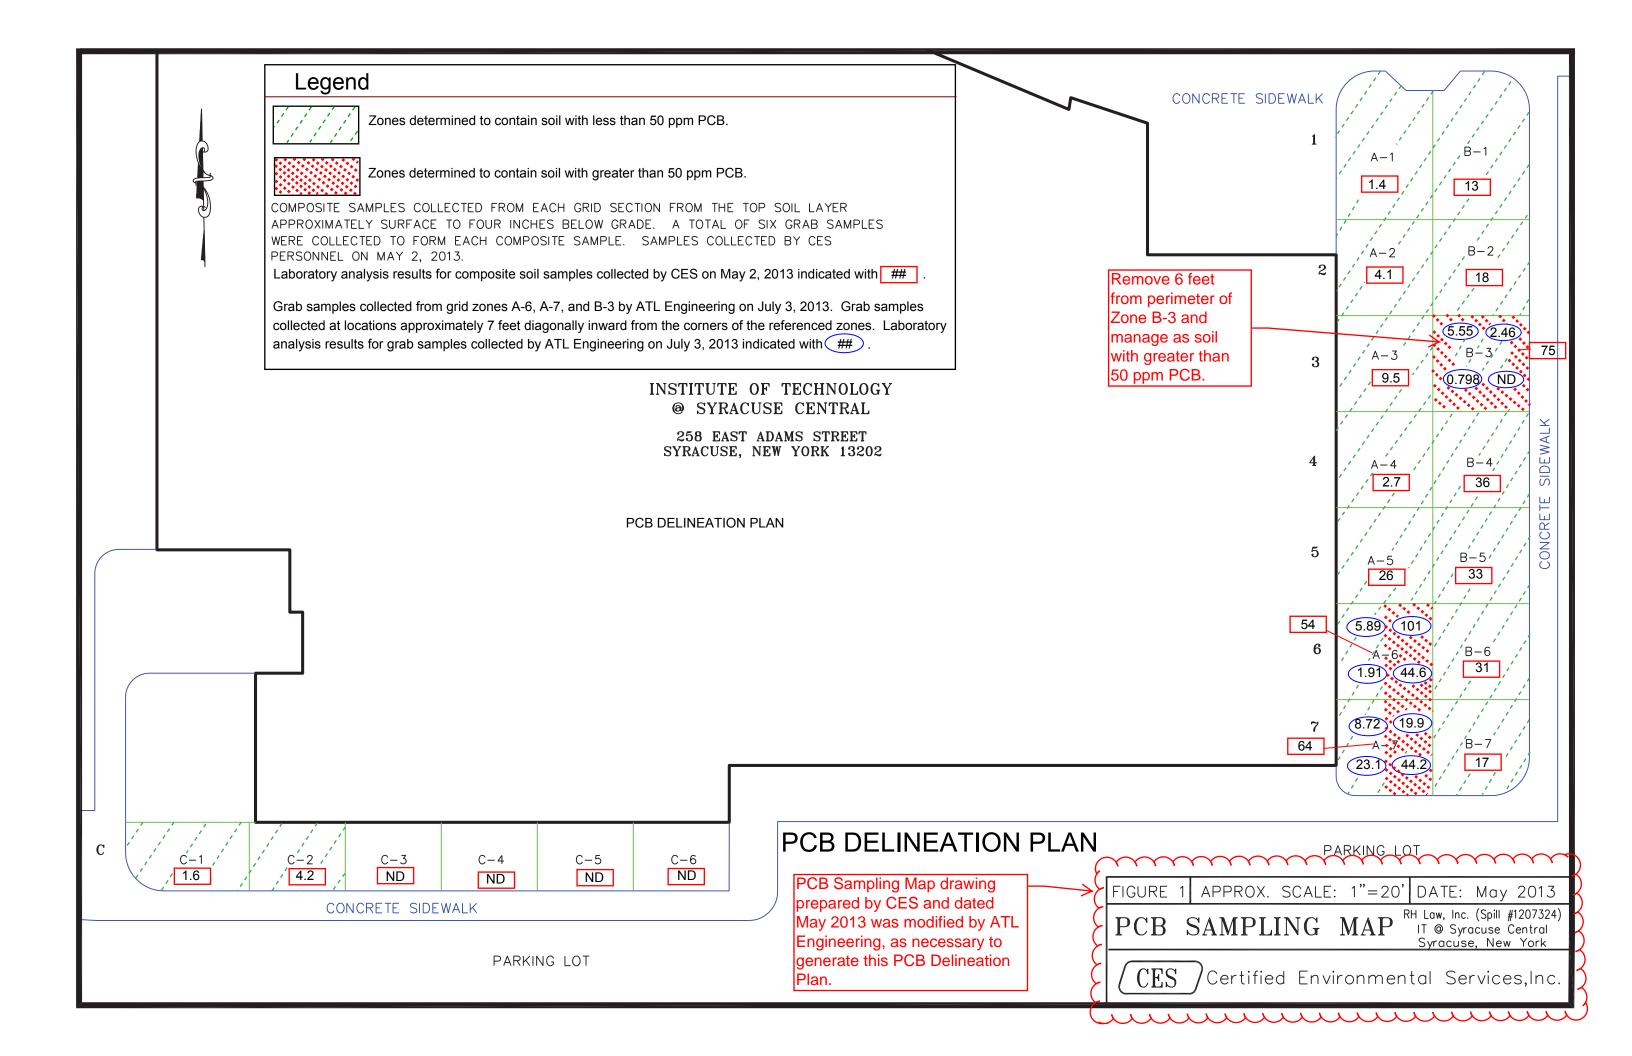
As indicated on the PCB Delineation Plan in Appendix B and further discussed in Section 2.3, soil investigations conducted to-date have been performed by segmenting the affected areas into zones. The area on the east side of the school building was segmented into 14 zones, identified as A-1 through A-7 and B-1 through B-7. The area on the south side of the school building was segmented into 6 zones, identified as C-1 through C-6.

(i.e., material within the range of 40 to 49 ppm). The PCB Delineation Plan, contained in Appendix B, shows areas with soil determined to contain greater than 50 ppm PCB and areas with soil determined to contain less than 50 ppm PCB.

Soil sampling and analysis, conducted by CES in May 2013, identified PCB within the topsoil material. The sampling was performed in accordance with a sampling plan submitted to the NYSDEC by CES and dated April 19, 2013. Composite soil samples were collected from segmented zones on May 2, 2013. The collected samples were laboratory analyzed by CES, a New York State Department of Health (NYSDOH) Environmental Laboratory Approval Program (ELAP) approved laboratory (ELAP No. One of the collected samples was split and submitted to Life Science Laboratories, Inc. (LSL) for analysis. LSL is a NYSDOH ELAP approved laboratory under ELAP No. 10248. CES performed PCB analysis in accordance with EPA Method 8082, using Soxhlet extraction (EPA Method 3540C). LSL performed PCB analysis in accordance with EPA Method 8082, using ultrasonic extraction (EPA Method 3550B). A summary of the laboratory analysis results for soil samples collected by CES is included in the Soil Investigation Report prepared by ATL Engineering and dated July 11, 2013. A copy of this report is contained in Appendix C. The PCB Delineation Plan, contained in Appendix B, depicts the analytical results for each sampled zone.

The soil samples collected by ATL Engineering on July 3, 2013, were submitted to Pace Analytical Services, Inc., located in Schenectady, New York, a NYSDOH ELAP approved laboratory (ELAP No. 11078). The samples were extracted by Accelerated Solvent Extraction (ASE), in accordance with EPA Method 3545, and laboratory analyzed for PCB, in accordance with method EPA Method 8082. A summary of the laboratory analysis results is included in the Soil Investigation Report prepared by ATL Engineering and dated July 11, 2013. A copy of this report is contained in Appendix C. The PCB Delineation Plan, contained in Appendix B, depicts the analytical results for each sampled zone.

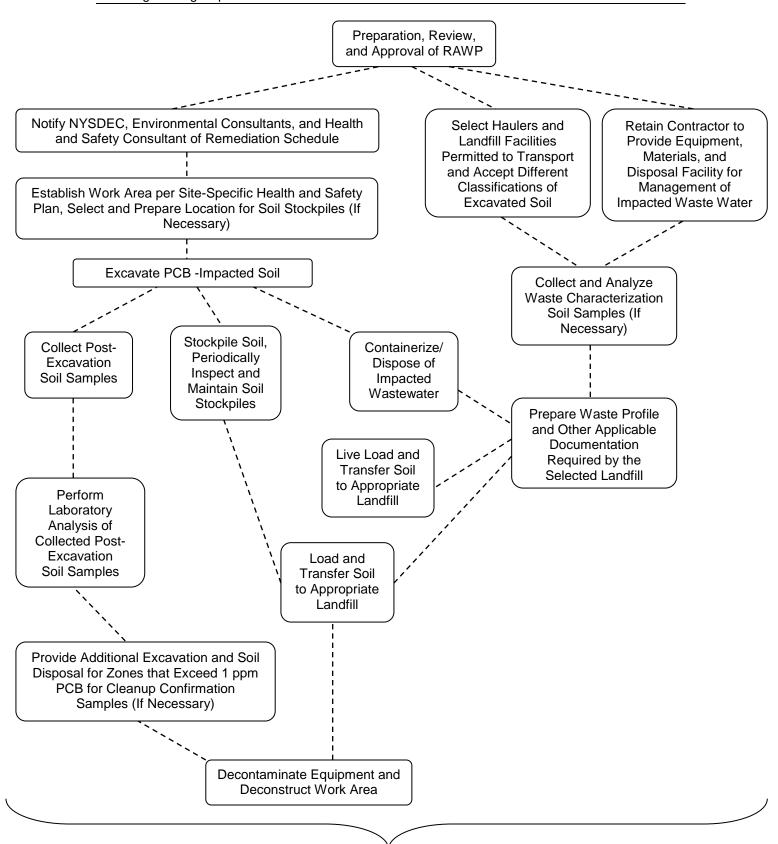
Project Remediation Flow Chart

The following sections summarize proposed remedial action that will be implemented at the subject site. In general, proposed remedial activities include removal and segregation of impacted soil, disposal of soil at approved landfill facilities, and subsequent post-excavation confirmation sampling and analysis. A Project Remediation Flow Chart, contained in Appendix D, depicts a general outline of the proposed remedial action steps.

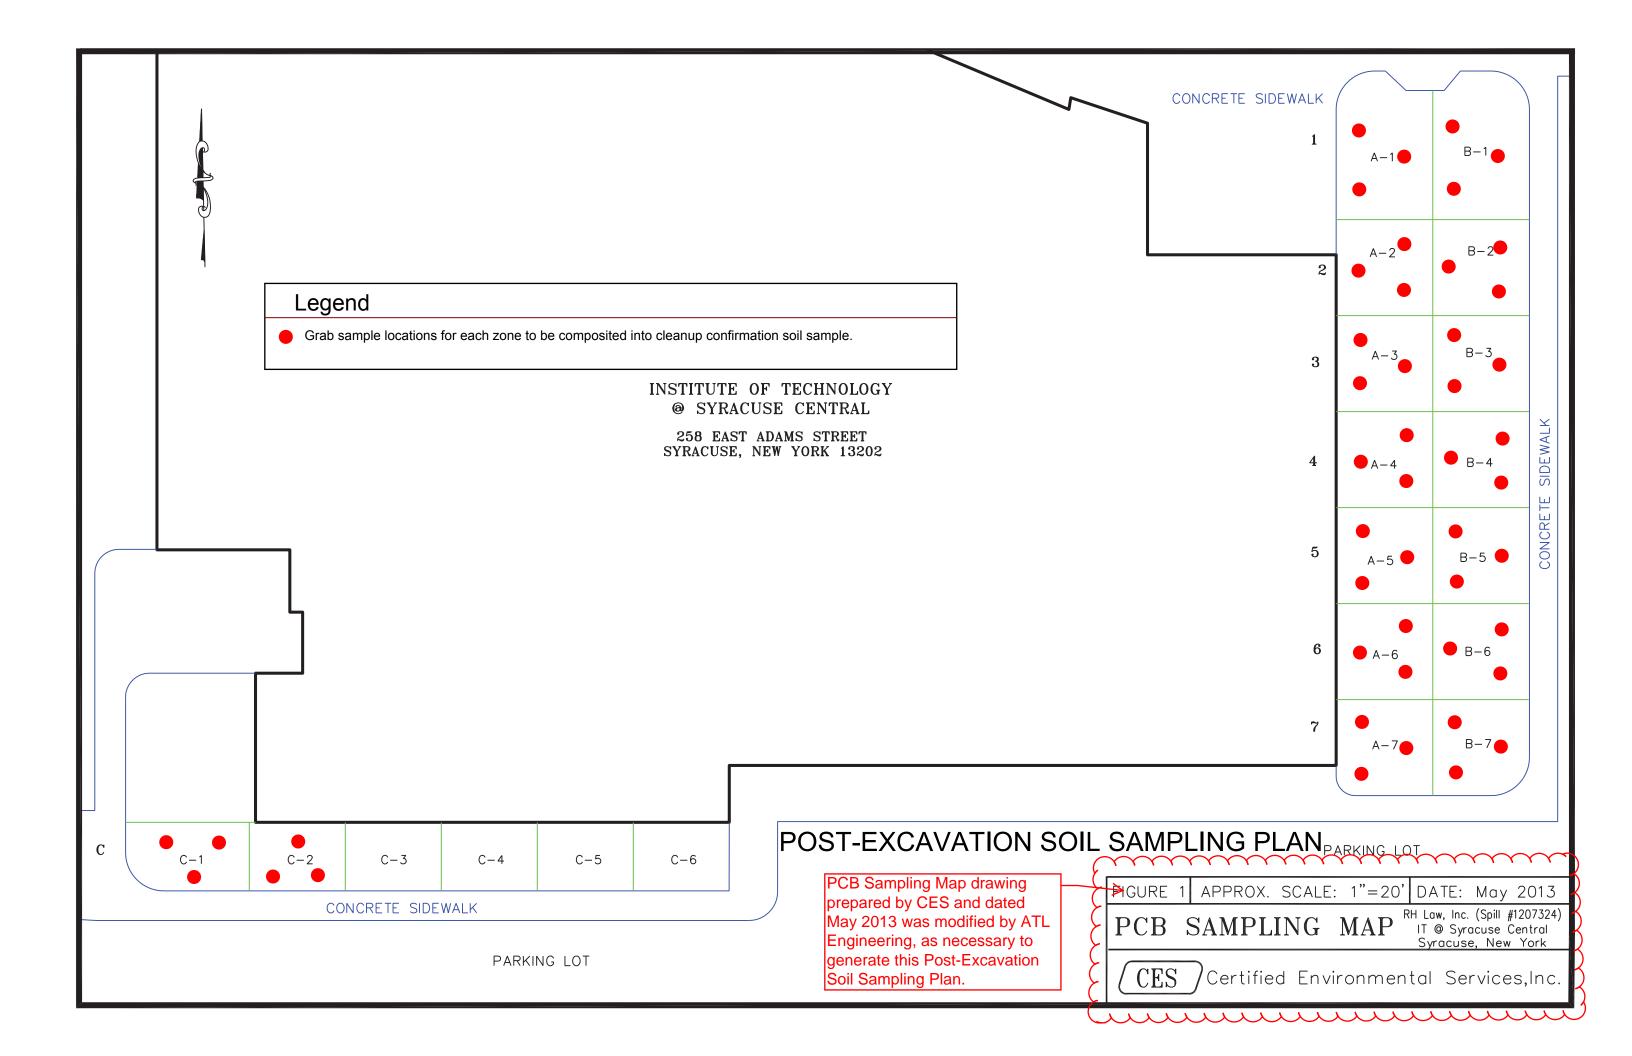
Post-Excavation Soil Sampling Plan

Prior to, or during, the excavation activities, cleanup confirmation soil samples will be collected from each excavated zone. The soil sample from each zone will consist of three grab samples collected in a triangular pattern within the zone and subsequently composited into a single sample for laboratory analysis. The Post-Excavation Soil Sampling Plan, contained in Appendix E, shows the general layout of the cleanup confirmation soil sample locations.
